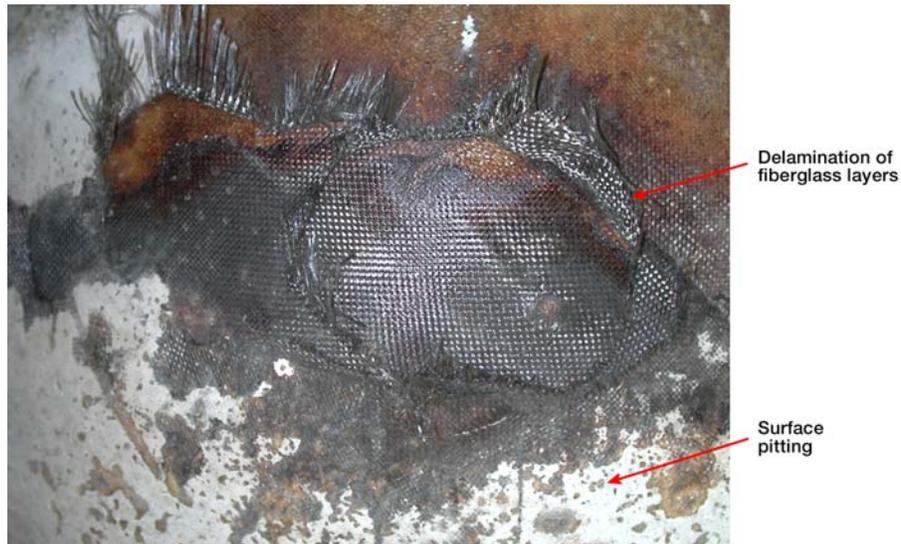
Figure 3.2-22. Delamination and pitting damage.

Thermal effects were apparent throughout all helmet surfaces. Significant variations in thermal conditions were noted from helmet to helmet (both interior and exterior helmet surfaces). The reflective tape was missing from all of the helmets, and fiberglass delaminations of various sizes and depths were observed. Some white paint remained, except in the areas removed via fiberglass delamination. Residual paint on the exterior helmet surfaces shows signs of damage (pitting) that are consistent with impacts with many small debris items. Figure 3.2-22 shows examples of delaminations and pitting damage.

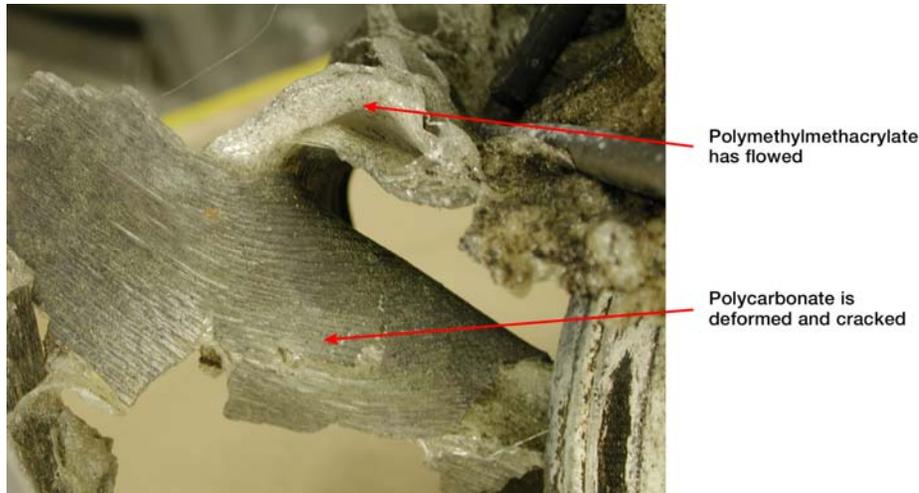
Figure 3.2-23. *Helmet pressure visor thermal effects.*

On all three helmets that have remaining pressure visor material, the polymethylmethacrylate flowed and pyrolyzed and the polycarbonate flowed in some places but did not pyrolyze (figure 3.2-23). Therefore, helmet visor materials experienced at least 300°F (149°C), which is the glass transition temperature of polycarbonate, to over 572°F (300°C), the pyrolysis temperature of polymethylmethacrylate, but certainly less than 752°F (400°C), which is the pyrolysis temperature of polycarbonate. Although there were small localized areas of fiberglass pyrolysis, in no case was there global pyrolysis of the helmet fiberglass material, indicating that the helmets did not experience temperatures globally above 735°F (391°C).

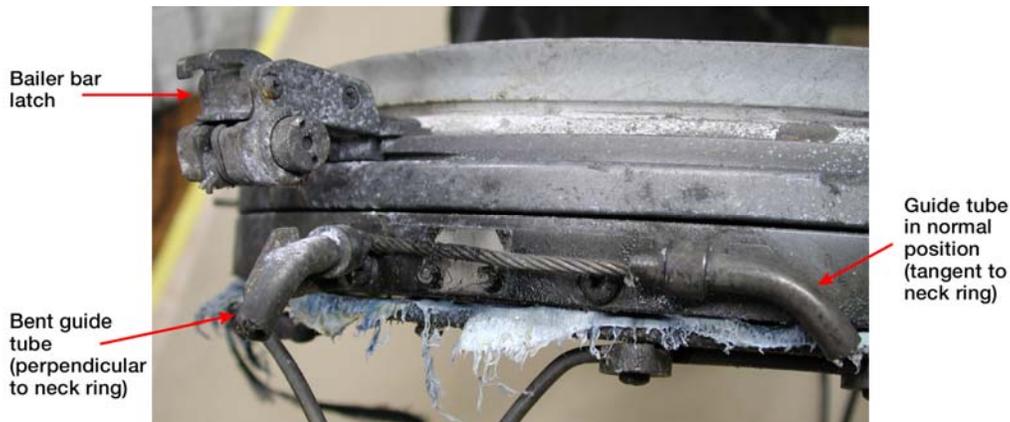
Figure 3.2-24. Hold-down cable guide tube.

The hold-down cables on each neck ring were severed at the attach points to the cable guide tubes due to mechanical overload (figure 3.2-24). Most cable guide tubes experienced significant plastic deformation. The guide tubes display evidence of external contaminants (i.e., melted metal and suit material) and thermal effects on top of the fractures and localized deformation. This indicates that mechanical loading preceded exposure to the thermal environment. Rotation of the helmet relative to the normal forward position was observed on all neck rings varying from 90 to 180 degrees. Major cable guide tube deformation and helmet rotation indicates that a significant loading event occurred where helmets were removed via a mechanical (nonthermal) mechanism.

The bailer bar latch mechanisms on five of the seven helmets remained attached to the helmets in good condition (figure 3.2-24). This would not be expected if the crew members had lowered and locked their visors. Mechanical separation of the bailer bar would be accompanied by fracture of the latch assembly if the visor was down and the bailer bar was locked. The other two helmets experienced latch mechanism separation due to failure of the fasteners that attach the latch mechanism to the helmet before subsequent deposition of melted suit materials. This suggests that latch separation was followed by suit melting. Neither of the two helmets shows evidence of the indentation or deformation that would be associated with forces expected if the bailer bar ripped the latch from the neck ring. Combined with the absence of melted visor material on the visor seal, this confirmed the conclusion that none of the crew members lowered and locked visors.

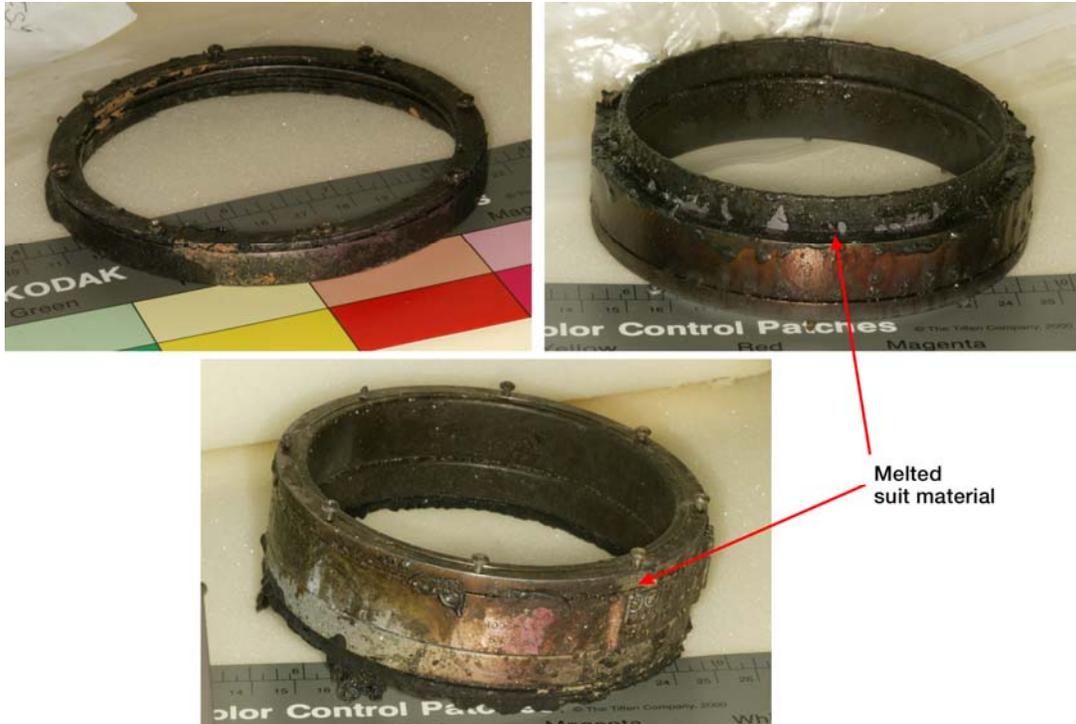
Figure 3.2-26. Recovered suit-side (upper left), glove-side (upper right), and mated (bottom) glove disconnects.

Melted aluminum deposits and/or tiny craters were observed on most of the glove and suit rings. Melted suit material (figure 3.2-26) was discovered on all recovered disconnect rings. Close inspection of the suit bladder clamp interface on the suit-side disconnect rings revealed mainly nylon and Teflon materials. In all cases, minimal amounts of Nomex remained clamped to the interface. Overall, the amount of residual melted suit material seems to correlate with the general magnitude of heating; that is, higher-magnitude heating resulted in the pyrolysis of residual suit material. As with the helmets, deposition of melted suit material on the glove disconnect areas occurred after mechanical separation. Small fragments of suit material were still clamped in the disconnect after mechanical separation. The failure modes at the disconnect ring (the ring-to-suit material interface) were similar to those observed in the suit-side helmet disconnect rings (see Section 3.2.5).

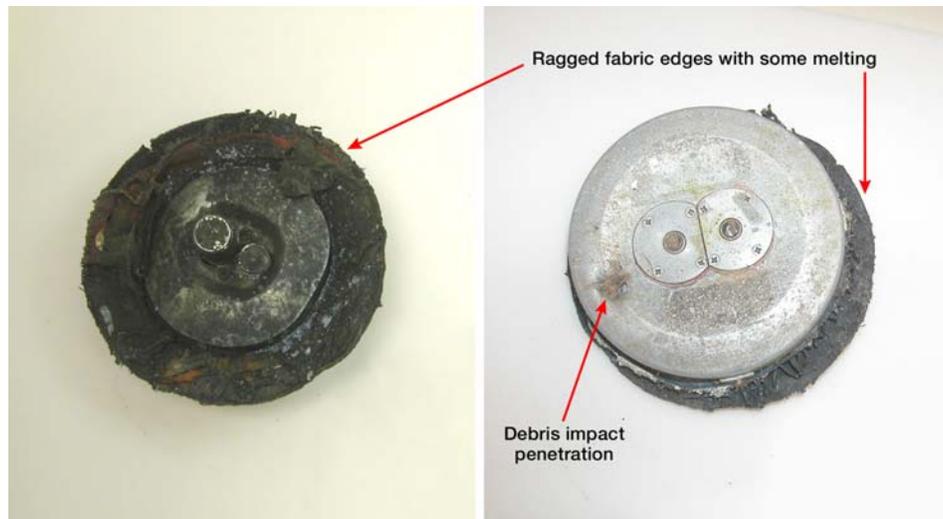
Figure 3.2-28. Recovered dual suit controller front (left) and back (right).

areas. Although melting of the torn fabric edges and the Velcro® indicates thermal exposure, the complete lack of thermal damage to any of the internal soft goods suggests that the thermal exposure was limited in intensity and/or duration.

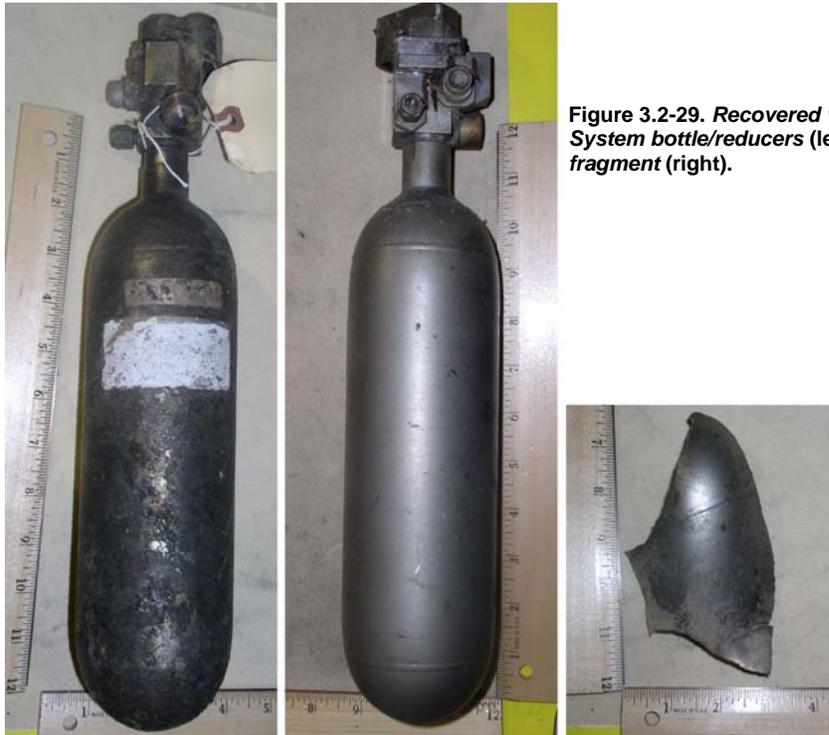
Figure 3.2-29. Recovered whole Emergency Oxygen System bottle/reducers (left and center) and a bottle fragment (right).

Ten whole EOS bottle/reducers were recovered (eight were ascribed to specific crew members), each with no O₂ remaining. All 10 of the recovered EOS bottle/reducers have similar appearances, with some variance in the amounts of material deposition. Additionally, three fragments of bottles were also recovered (figure 3.2-29).

No nylon material from the parachute harness adhered to the bottle/regulator assemblies. Minor evidence of elevated temperatures, directional burn marks, and discrete external impacts are visible. As with most of the *Columbia* hardware, corrosion that occurred while the debris was on the ground is also evident. X ray revealed that all of the EOSs were activated. However, the crew members were trained not to activate them unless their visors were down. Therefore, activation of the EOS (achieved by applying tension to the activation cables) probably occurred as the bottles separated from the harnesses rather than by crew action.

The EOS bottle fragments exhibited irregular edges along the fracture surfaces, some outward bent edges, evidence of heating on the inner surfaces, and some deposited/flowed black material along a fracture surface.

Heating on the inner surfaces indicates that the bottle failure occurred before the end of entry heating. Neither the cause of the bottle failures nor the status of the bottles at the time of failure (pressurized or unpressurized) could be determined.

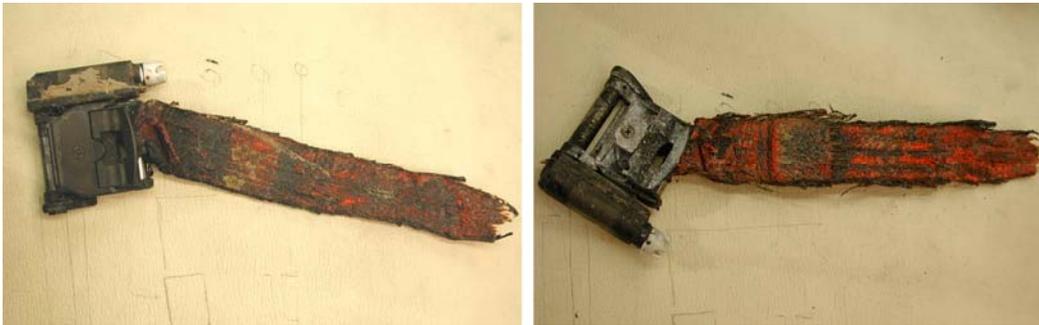
Six SEAWARS were recovered. None had automatically ignited, and all had both of the Frost fitting male and female halves still mated. All SEAWARS had similar appearances (figure 3.2-30), consisting of the SEAWARS assembly still attached to approximately 12 in. of nylon parachute harness strap. None had any parachute riser material attached.

Figure 3.2-30. Seawater Activated Release System with Frost fittings (male/female) still mated, with a segment of harness strap attached (two different SEAWARS are shown).

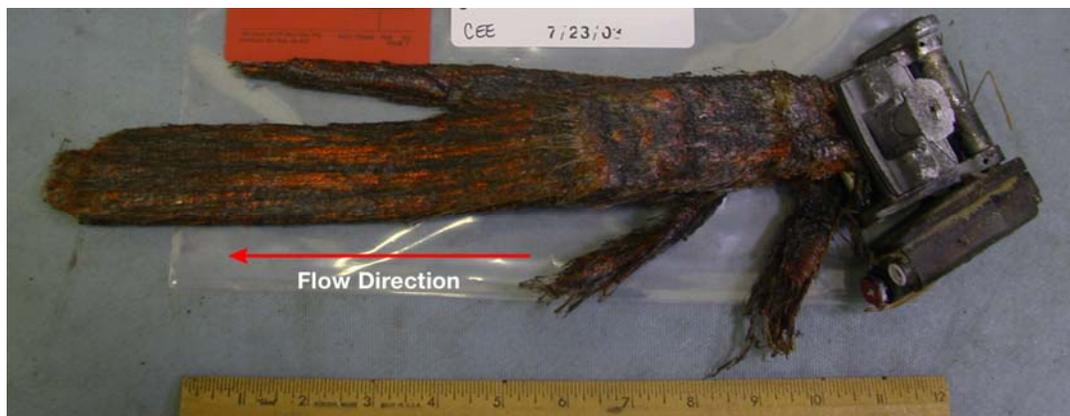
Each SEAWARS/strap item shows evidence of directional melting, burning, and mechanical loading. The surviving length of parachute harness strap is consistent with a harness strap failure at the waist. While the terminating ends show evidence of melting on the top layer of fabric, these ends appear to have failed primarily due to mechanical overload, not melting. Some surface melting occurred along the length of the straps, with distinct directionality away from the SEAWARS towards the broken end of the strap, corresponding to a head-to-foot direction when the harness is on a crew member. These directional heating/melting features are present on both sides of the straps, with little difference between the front and the back of the straps. Because both sides of the straps show signs of heating, the heating and melting must have occurred after the straps had separated from the crew member. Localized heating on the metallic SEAWARS Frost fitting buckle suggests intense, short-duration heat exposure. Each SEAWARS and strap was mechanically extracted from the harness webbing before experiencing this short-duration heating. Directionality suggests that each piece of riser trimmed with the SEAWARS into the airflow (figure 3.2-31).

Figure 3.2-31. Directional melting on Seawater Activated Release System/parachute harness strap.

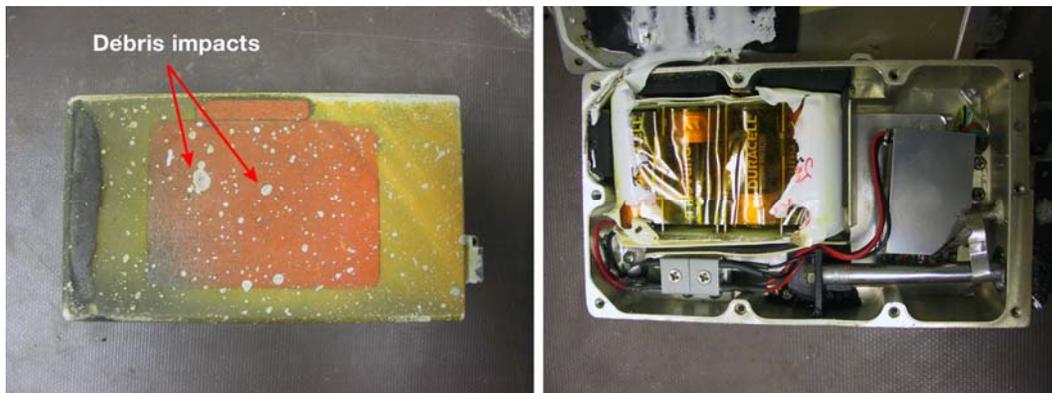
One TSUB-A SARSAT beacon is flown per crew member; it is located in the survival raft packed in the PPA. Six SARSAT beacons were recovered; none of them were activated during the accident. All six recovered SARSAT beacons show similar thermal and mechanical damage (figure 3.2-32).

Figure 3.2-32. External (left) and internal (right) views of a recovered search and rescue satellite-aided tracking beacon.

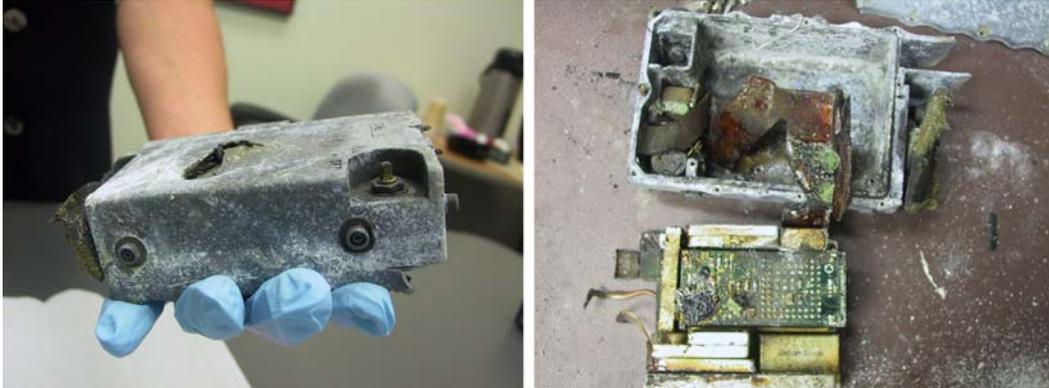
Four A/N PRC-112 radios were recovered, all of which looked similar (figure 3.2-33). No Nomex material from either the suit pocket or the survival gear pouch was adhered to the outer aluminum casing. Various amounts of paint showed evidence of impact with small, hot metallic pellets. Corrosion was also present. All external plastic was melted or missing. Internal inspection of the radios revealed evidence of moderate heating, with the center-most components experiencing only minor solder re-flow. For each of the four radios that were recovered, the control module was extracted and interfaced with ground support equipment to read the unique identifier of the radio. Thus, all four radios were ascribed to a specific crew member. Overall appearance suggests that each A/N PRC-112 radio experienced similar thermal and mechanical environments. Each radio was mechanically extracted from the ACES pocket and the survival gear pouch as temperatures were rising and, for a short duration and nearly simultaneously, each of the radios experienced high heating and a hot metal pellet-like shower. This indicates a rapid disruption of the suit survival gear pockets, releasing the radios while they were still in close proximity to the CM debris cloud.

Figure 3.2-33. External (left) and internal (right) views of a recovered Army/Navy personal radio communications-112 radio.

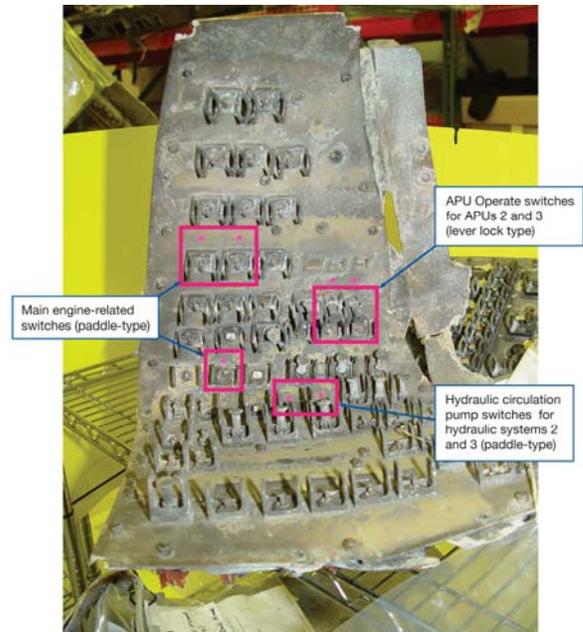
Figure 3.3-4. Recovered R2 panel from Columbia (after it was unfolded). Pink dots are above the out-of-configuration switches.

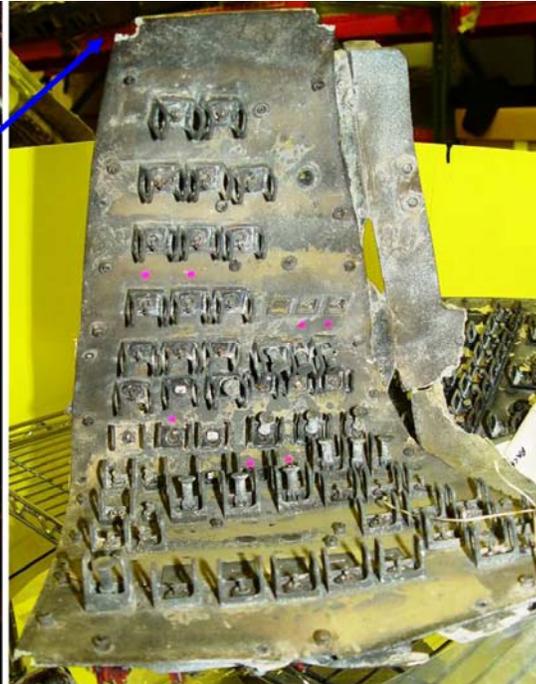
Figure 3.4-11. Recovered R2 panel from Columbia (after it was unfolded). Pink dots are above the out-of-configuration switches.
