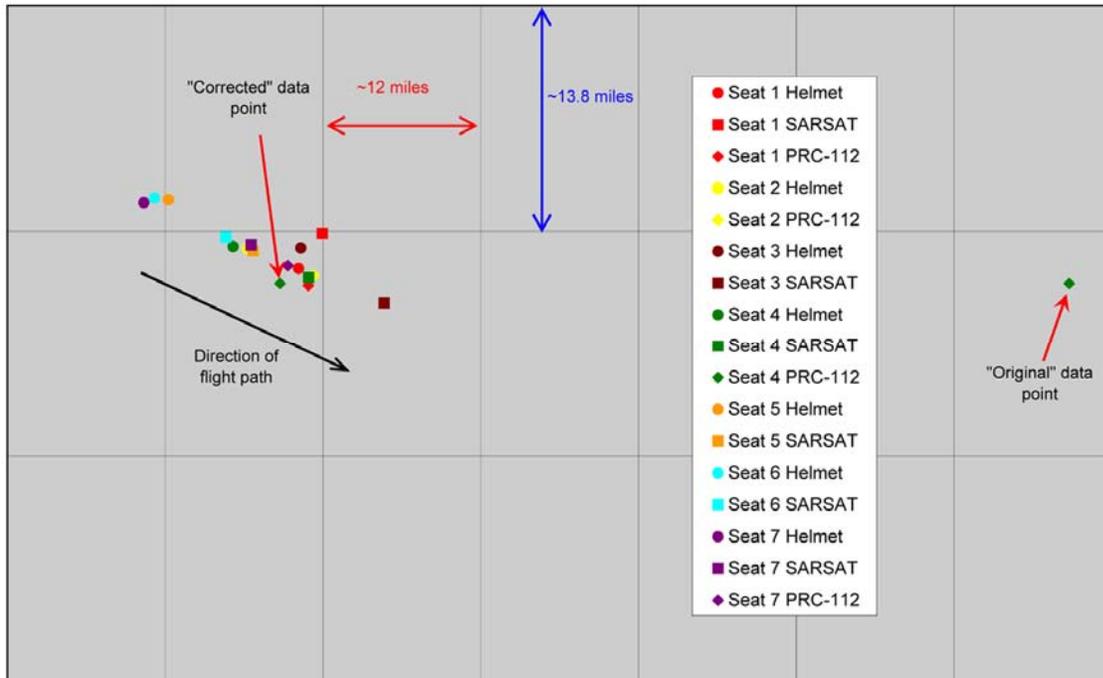
Figure 3.2-34. Relative location of helmets, search and rescue satellite-aided tracking beacons, and Army/Navy personal radio communications-112 radios.

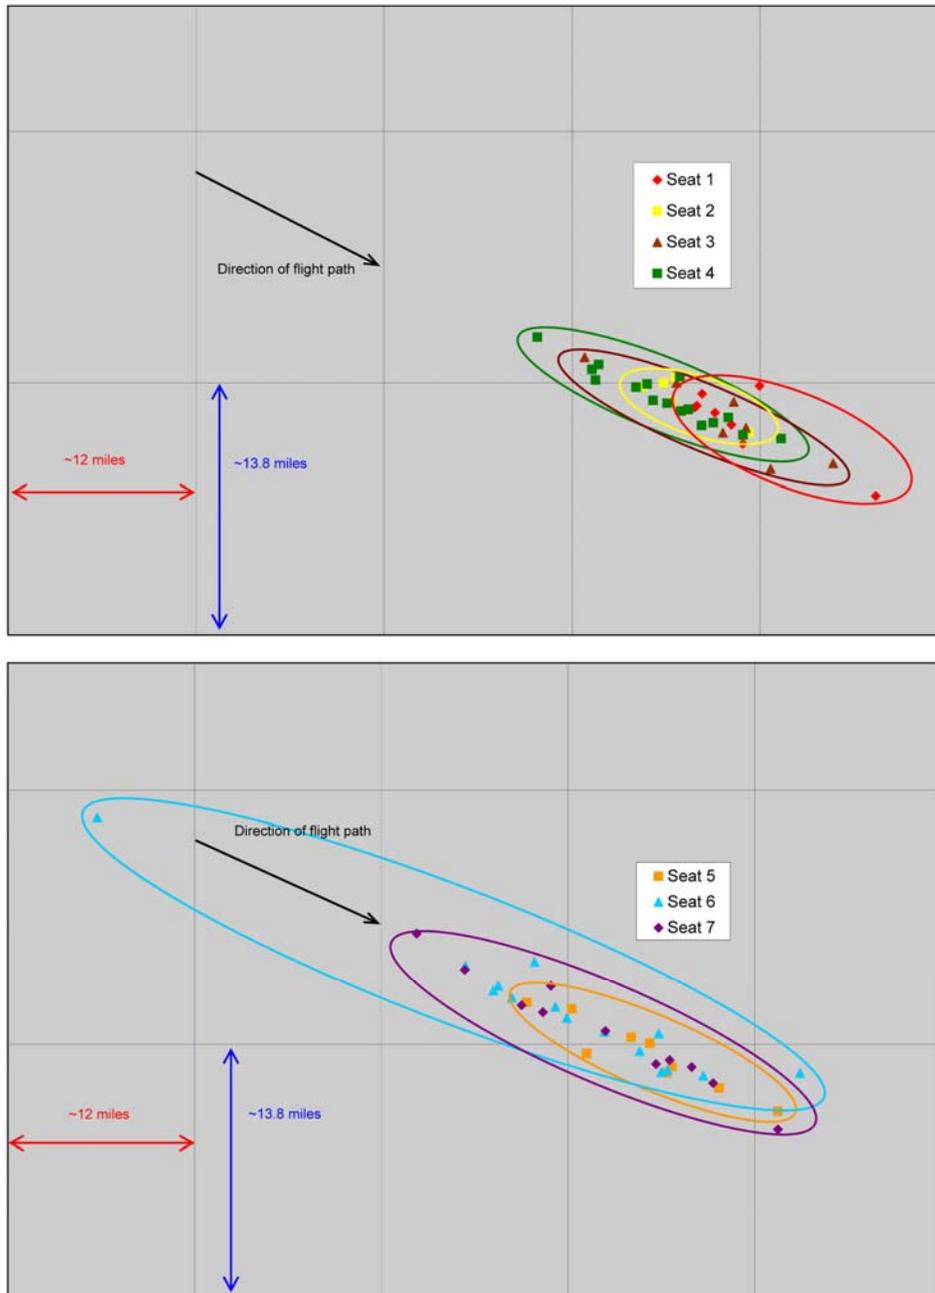
The investigation team concluded that the middeck crew members separated from the CM before the flight deck crew members. Orders within the middeck/flight deck groups cannot be determined conclusively, but it appears that seat 6 and seat 7 equipment items were first out of the middeck and seat 4 equipment was first out of the flight deck. All CEE associated with specific crew members was plotted by crew member. Analysis looking at the relative centers of the areas of recovered items for each crew member supports this conclusion. Figure 3.2-35 shows the locations of the recovered items for each crew member. The upper plot shows items for the flight deck crew members; the lower plot show items for the middeck crew members. Both plots are the same scale and represent the same geographic area.

Figure 3.2-35. *Relative locations of all crew escape equipment – flight deck crew members (top) and middeck crew members (bottom).*

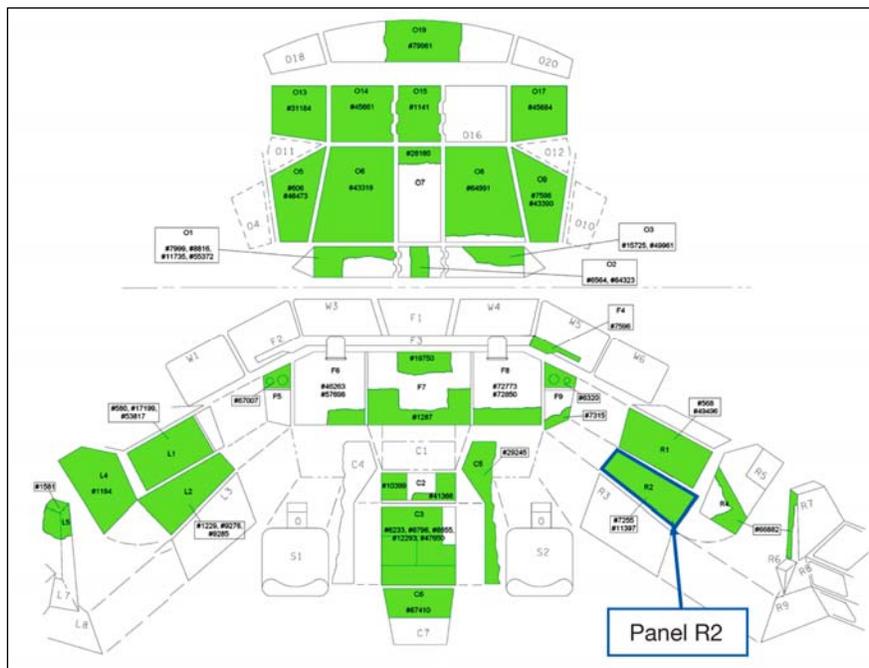
Figure 3.3-2. Columbia recovered flight deck forward panels (highlighted in green).

No further analysis was performed at that time as it was not possible to know whether the switch positions were due to crew action, the mishap, or handling during debris recovery. However, the R2 panel, to the immediate right of the PLT on the flight deck (figure 3.3-2), warranted further investigation. This panel contains the primary controls for the auxiliary power units (APUs). The APUs drive the hydraulic pumps that provide hydraulic pressure to the flight control surface actuators. During entry, these surfaces become increasingly important to vehicle control, and loss of hydraulic pressure can have catastrophic results. Reconstructed general purpose computer (RGPC)-2 data revealed that the hydraulic systems failed prior to GMT 14:00:03 while the crew was conscious and capable of taking action.

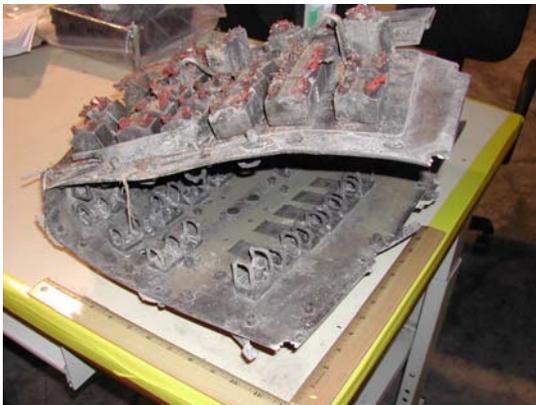
When recovered, the R2 panel was folded back in on itself (figure 3.3-3), protecting the innermost switches from manipulation during recovery operations. The switch positions were considered to be unaltered by external factors, making the switches valuable in determining crew actions.

Figure 3.3-3. Recovered R2 panel from Columbia.

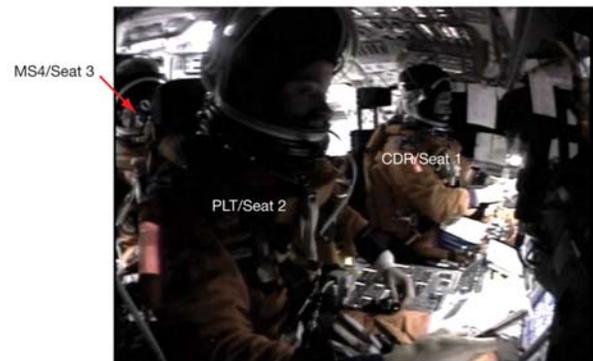
The initial phase of entry went without incident. A recovered flight deck video (figure 3.4-4), which runs from approximately GMT 13:35:34 to GMT 13:48:45, provides insight into the crew events taking place on the flight deck.

Figure 3.4-4. Video frame-capture from the recovered flight deck video.

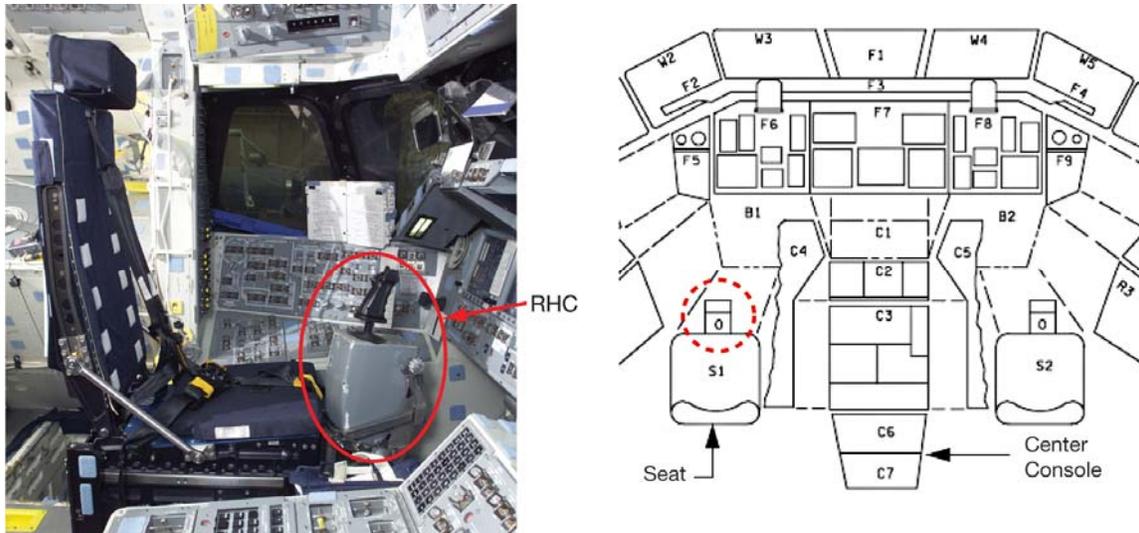
The video shows that, at GMT 13:36:04, the CDR bumped the RHC accidentally (figure 3.4-5). Movement of the RHC out of the centered position caused the digital autopilot (DAP) to “downmode” from “Auto” mode to “Inertial” mode. When this occurred, a “DAP DOWNMODE RHC” caution-and-warning message was displayed, the INRTL button on the C3 panel was illuminated, and a tone, which can be heard in the recovered flight deck video, was annunciated. An immediate reactivation of the autopilot was performed by the CDR. The CAPCOM in the MCC then requested the CDR to enter “another Item 27,” which is a command to fully recover the vehicle attitude from the bumped RHC. The CDR complied, and is heard on the recovered videotape commenting that he had forgotten that he needed to perform an Item 27 after a stick bump but had noticed the guidance needles “weren’t really down where they needed to be.” This indicates that the CDR was scanning the displays, noticing that the guidance needles were not centered after the stick bump, and was properly processing the information.

Figure 3.4-5. Location of the Commander's seat and the rotational hand controller. [Left picture from a shuttle training mockup in the JSC Space Vehicle Mockup Facility, looking from starboard to port; right picture adapted from the Space Shuttle Systems Handbook, looking from aft to forward]

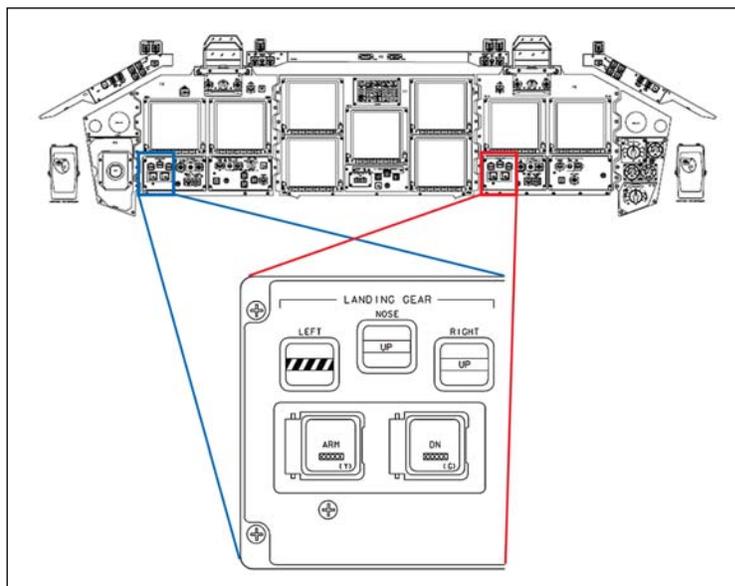
At GMT 13:59:06, 10 seconds after the fourth of four tire pressure fault messages, telemetry indicated that the “LEFT MAIN GEAR DOWN” lock sensor transferred to “ON.” Other sensors indicated that the landing gear door was still closed and the landing gear was locked in the “up” (stowed) position. These mixed signals caused the left landing gear position indicator to display a “barber pole” (figure 3.4-6), which indicates an indeterminate landing gear position. Post-accident analysis of the data and recovered debris indicates that the left landing gear was locked in the “up” position and the landing gear door was closed. The signal indicating that the gear was down was a false signal that was likely triggered by damage to the sensor system (sensor, wiring harness, etc.). Based on training experience, the crew was probably attempting to diagnose the situation given that it involved the same landing gear as the tire pressure messages and indicated a potential landing gear deployment problem.

Figure 3.4-6. Landing gear indicator panel, identical on both sides of the flight deck forward display panels. Left indicator showing “barber pole” (indeterminate position). [Adapted from the Space Shuttle Systems Handbook]

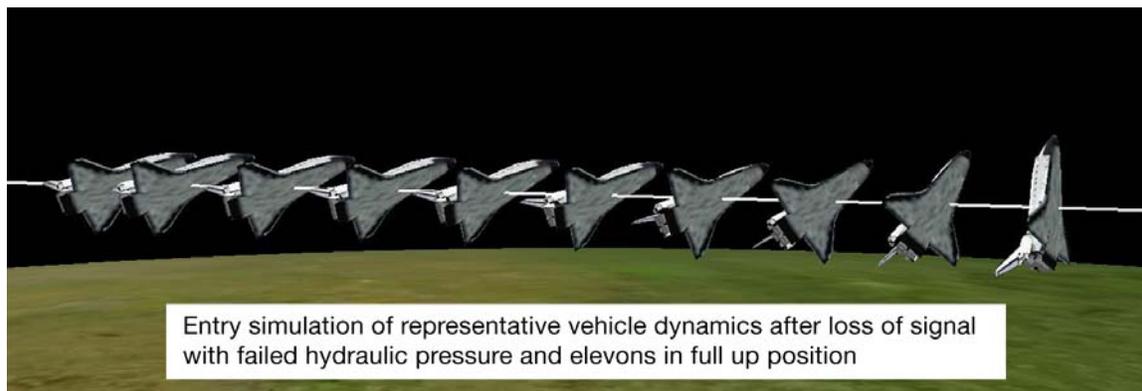
Based on engineering analysis and modeling (see Section 2.1), hydraulic pressure, which is required to move the flight control surfaces, was lost at approximately GMT 13:59:37. At that time, the Master Alarm would have sounded for the loss of hydraulics and the crew would have become aware of a serious problem. It is probable that the loss of hydraulic pressure as a result of the damage to the left wing resulted in an uncontrolled pitch-up and loss of vehicle control. A visual simulation of the pitch-up associated with this LOC scenario is shown in figure 3.4-7.⁶ The flight deck crew would have been the first to be aware of this owing to the changing light levels, the view of the horizon through the windows, and the information on the flight displays. Space-adapted crews are reported to be very sensitive to motions and G-loads. As the orbiter motion dynamics began to increase, all of the crew members likely would have sensed this motion and been aware of the off-nominal⁷ situation. At GMT 13:59:46, a “Roll Ref” alarm message was annunciated, indicating that the orbiter had exceeded the limits of the entry drag profile. In conjunction with the hydraulics messages and the unusual motion of the orbiter, the “Roll Ref” message would have reinforced the fact that a serious problem had developed.

Figure 3.4-7. Sequence (1-second intervals) showing a simulation of orbiter loss of control pitch-up from GMT 13:59:37 to GMT 13:59:46. White line indicates vehicle trajectory relative to the ground.

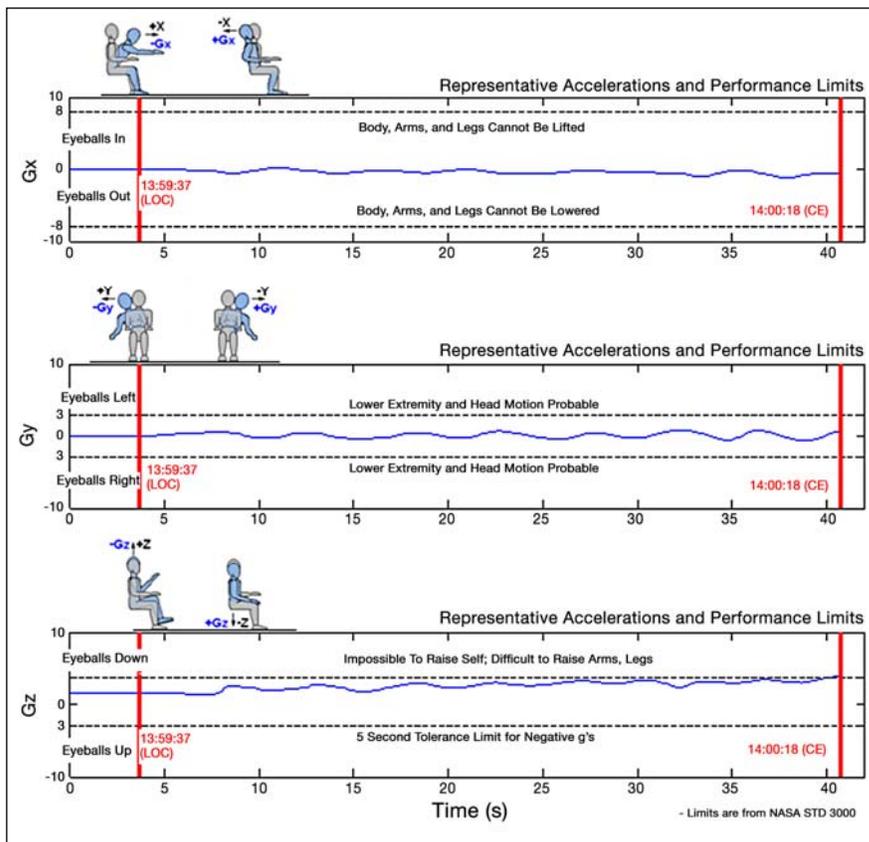
Figure 3.4-9 shows representative loads based on modeling in all three axes, including the effects of increasing rotational loads. Models showed that accelerations were initially low, and peaked between 2 G and 3.5 G by the time of the CE (separation of the forebody from the midbody). The dashed black lines (upper and lower) on the chart indicate human performance limits based on NASA-STD-3000.¹⁰ The representative loads, which are based on modeling, were well within these human performance limits.

Figure 3.4-9. Representative accelerations from modeled motion analysis from loss of control to the Catastrophic Event (see Section 2.1). Black dashed lines show human performance limits.

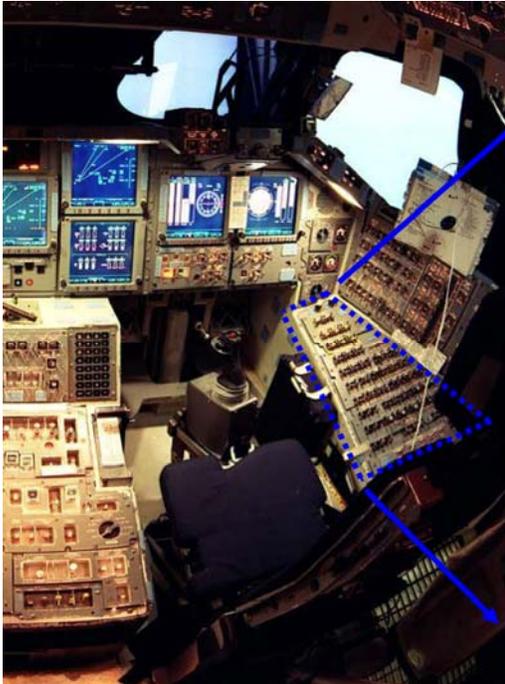
Recovered debris revealed that the APU Operate switches on flight deck panel R2 were in positions that were consistent with an attempted restart of two of the three APUs¹¹ (figures 3.4-10 and 3.4-11). The hydraulic circulation pump paddle switches for the two hydraulic systems corresponding to the two APUs were also turned on. While turning on the hydraulic circulation pump is not in any crew emergency checklist, the pump can provide some hydraulic pressure, and this action shows good systems knowledge by the crew members as they responded to the limited information presented to them and worked to restore orbiter control. The APU Operate switches are “lever-lock” switches that require three actions to change the position. They must be (1) pulled outwards to disengage the switch lever from the lock, (2) moved to the desired position, and (3) released (figure 3.4-12). The switches are spring-loaded to hold them in the detents. The RGPC data indicate that all of these switches were in the nominal configuration up to GMT 14:00:04.826. These findings strongly suggest that despite the very dynamic vehicle motion, the PLT was still capable of taking appropriate actions to attempt a recovery of the hydraulic pressure by performing an APU restart at some time after GMT 14:00:04.826. Based on the panel R2 switch throws and the lack of visors being lowered, it is probable that the crew never realized that the vehicle LOC situation was unrecoverable and had become a survival situation.

Figure 3.4-10. Location of the R2 panel.
[Picture from the Shuttle Training Simulator]

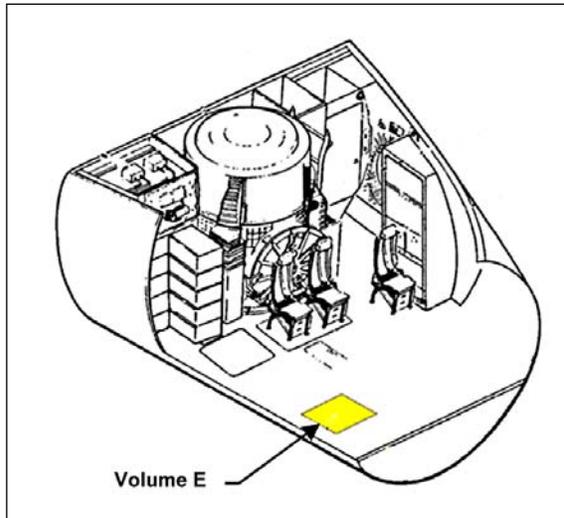
Analysis of several sources of information indicates that the forebody separated from the midbody at or shortly after GMT 14:00:18. It is unknown what accelerations occurred during separation of the orbiter forebody from the midbody; however, ballistic analysis estimates that the translational G that was experienced by the orbiter forebody at the CE decreased from approximately 3.5 G to 1 G. It is also likely that there were additional translational and rotational loads acting on the crew at this time. Analysis of structural debris supports that multiple small impacts occurred between the forward fuselage (FF) and the CM, including in the area of middeck Volume E (figures 3.4-13a and 3.3-13b).

Figure 3.4-13a. View of middeck floor and Volume E, looking aft.

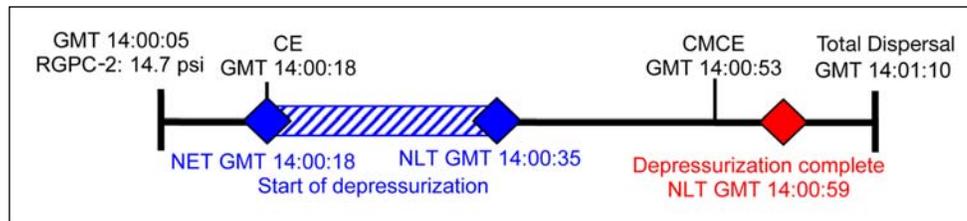
Figure 3.4-15. Cabin depressurization timeline.

However, additional research discussed in *Joint Aerospace Physiology, Air Education and Training Command/Bureau of Medicine and Surgery* shows that the physiological response to hypoxia during a rapid depressurization event at this extreme altitude (181,000 feet) would have reduced the conventional TUC interval by 50% (i.e., 12 seconds would have been reduced to 6 seconds). In addition to the depressurization effects, the physical exertion against the G-forces that the crew experienced at this time would further reduce the available metabolic O₂ reserves¹⁴ and increase the CO₂ partial pressure. Also, NASA research data indicate that de-conditioned crews have a reduced tolerance to G-loads.¹⁵ Further, anecdotal reports from accidental exposure to vacuum confirm much shorter periods of awareness as reported by survivors.¹⁶

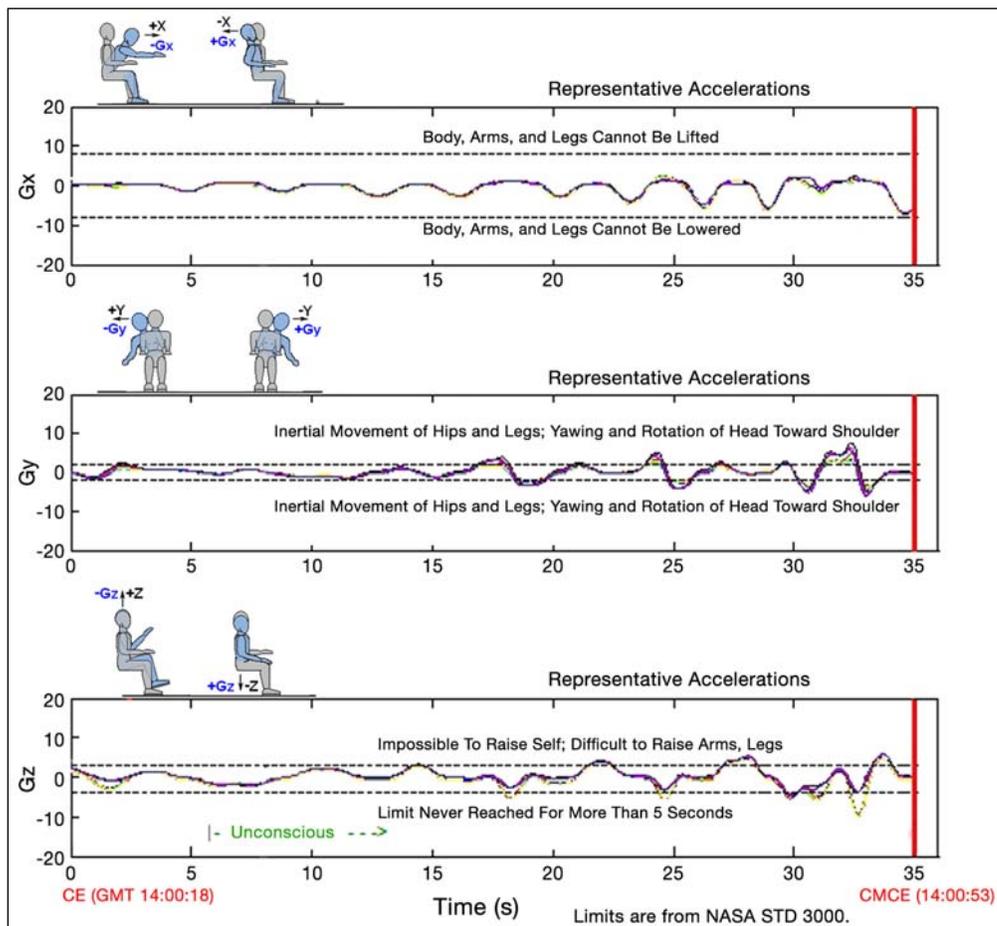
A very dynamic motion environment existed after the CE (GMT 14:00:18); this environment became more intense as the CMCE (the breakup of the forebody) approached at GMT 14:00:53. Figure 3.4-16 shows representative loads on the unconscious or deceased crew members based on aerodynamic modeling of the forebody dynamics post-CE. The black dashed lines showing human performance limits²⁰ are for conscious crew members. Based on the conclusion that the rapid depressurization occurred at or close to the time of the orbiter forebody separation, the crew was unconscious or deceased and unable to brace against these loads.

Figure 3.4-16. Representative acceleration profiles from the orbiter breakup (Catastrophic Event) to the orbiter forebody breakup (Crew Module Catastrophic Event) based on aerodynamic modeling. Black dashed lines show human performance limits.

For the first 15 to 20 seconds, the modeled loads would not cause serious injuries to a conscious crew member who was capable of active bracing. An unconscious or deceased crew member would have been more susceptible to injury.

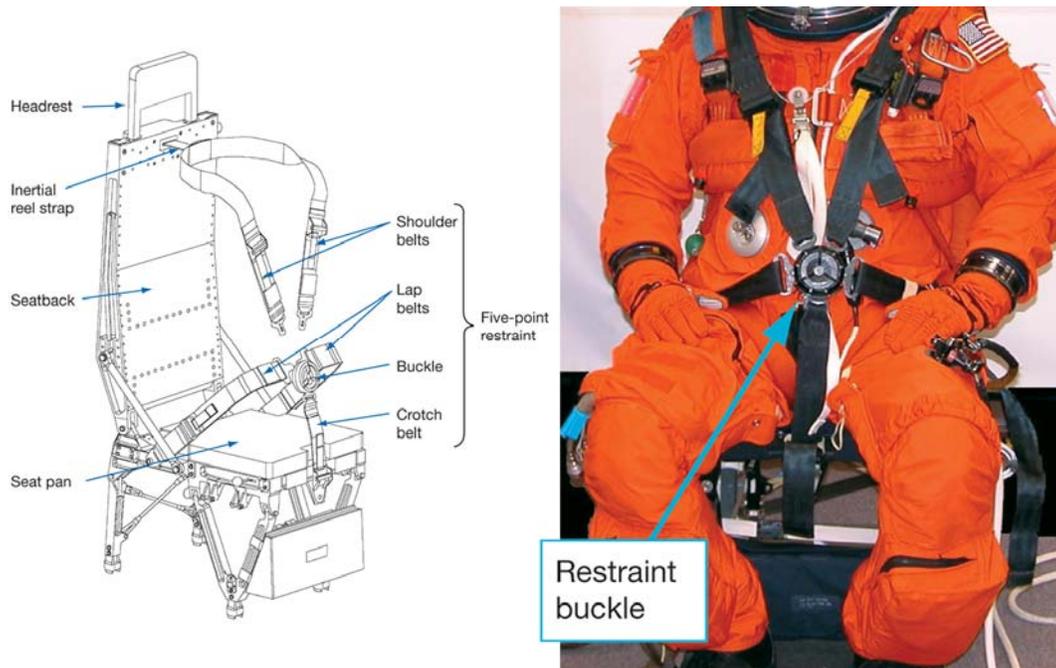
The crew is normally restrained in the seats by a five-point harness system (figure 3.4-17). A lap belt secures the lower torso. A crotch strap prevents “submarining.”²¹ Two shoulder harnesses, which attach to an inertial reel via the inertial reel strap, secure the upper torso.

Figure 3.4-17. Detail of the five-point harness.

Engineering analysis of the STS-107 restraints indicates that most of the inertial reel straps were extended and did not lock or retract prior to failure of the straps. The inertial reels are normally unlocked to allow the crew to access displays and controls with a full range of motion. With the inertial reels unlocked, the crew members’ upper bodies were left unrestrained during the forebody dynamics. [REDACTED.]

Finding. Injuries were consistent with the crew’s upper bodies not being securely held to the seatbacks and with the evidence indicating that the inertial reel straps were extended at the time of failure.

Recommendation L2-8. The current shuttle inertial reels should be manually locked at the first sign of an off-nominal situation.

Recommendation L2-9. The use of inertial reels in future restraint systems should be evaluated to ensure that they are capable of protecting the crew during nominal and off-nominal situations without active crew intervention.

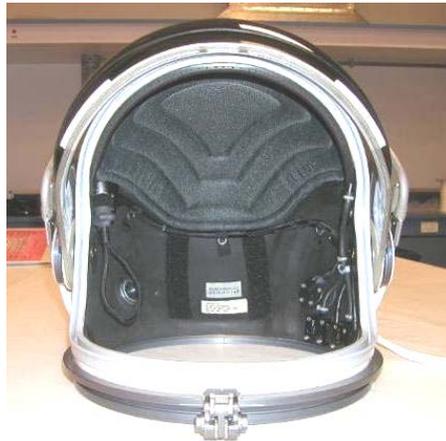
[REDACTED.] Figure 3.4-19 shows an interior view of an intact, pristine ACES helmet demonstrating exposed hardware. [REDACTED.]

Figure 3.4-19. Example of an intact, pristine advanced crew escape suit nonconformal helmet (not an STS-107 helmet).

Recommendation L2-7. Design suit helmets with head protection as a functional requirement, not just as a portion of the pressure garment. Suits should incorporate conformal helmets with head and neck restraint devices, similar to helmet/head restraint techniques used in professional automobile racing.

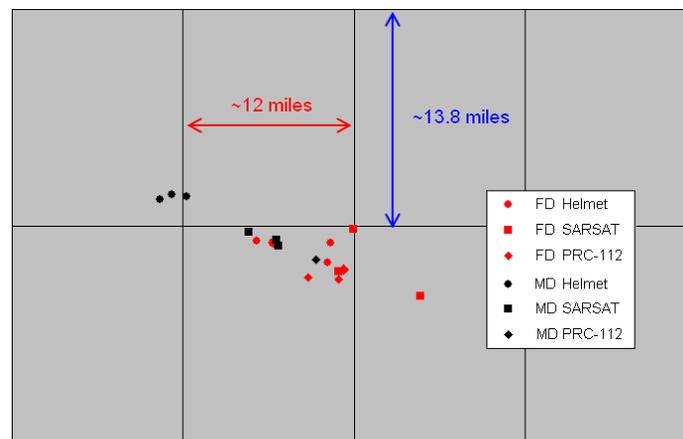
[REDACTED.] Engineering and ballistic analyses of the orbiter forebody failure indicate that the mid-deck separated prior to the flight deck. Crew members on the middeck separated along with the middeck accommodations rack, middeck lockers, sub-floor components, and Modular Auxiliary Data System/orbiter experiment data recorder – a scenario that is supported by debris plots (see Section 2.2). Based on structural design analysis, thermal damage, and position in the debris field, the flight deck “pod” and the CM aft bulkhead stayed intact for a longer time. The location of the recovered flight crew equipment, which is plotted in figure 3.4-21, supports the middeck departing prior to the flight deck.

Figure 3.4-21. Ground location of the recovered flight crew equipment.

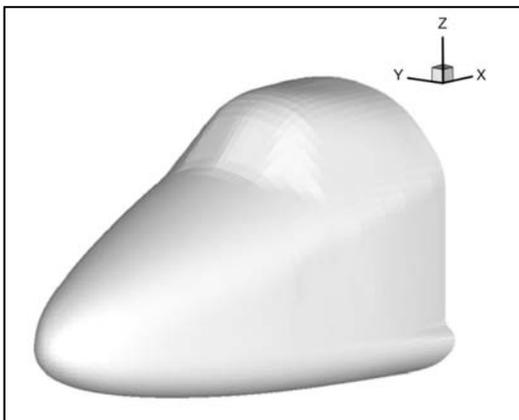
Figure 4-8. Forward fuselage/crew module (forebody) configuration.

The forebody configuration was idealized in that the mass properties were held constant from the CE to the CMCE and the aerodynamic geometry was symmetric. The configuration, which was an intact FF containing the CM, ended cleanly at the X_o 576 bulkhead. At the time, the team did not yet know that parts of the X_o 582 ring frame bulkhead stayed attached to the forebody. The forebody configuration is shown in figure 4-8.

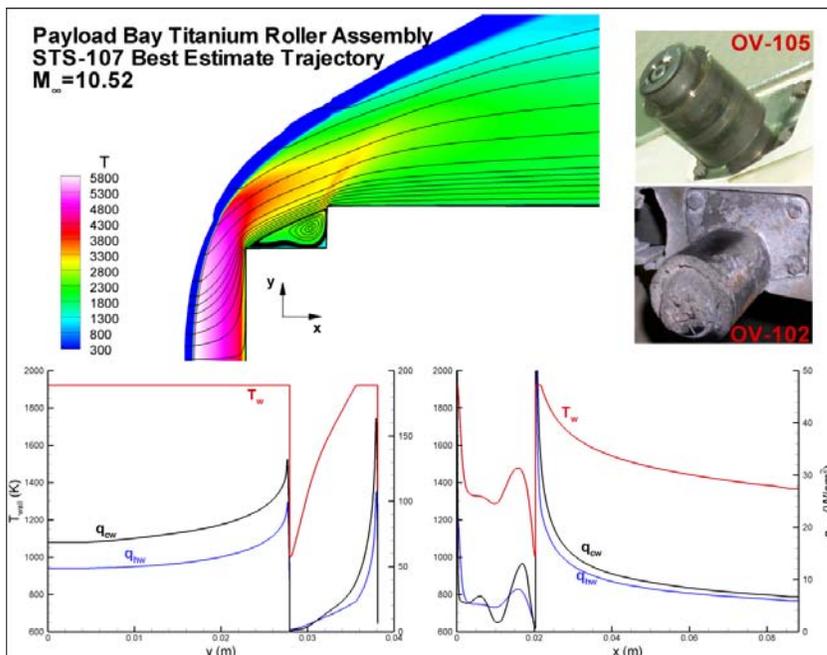
Figure 4-10. Computational fluid dynamics analysis of heating at the tip of the payload bay door roller for orthogonal geometry into the direction of travel at $M = 10.5$.

A computational fluid dynamics (CFD) thermal analysis of the payload bay door rollers was performed by the JSC Applied Aerosciences & CFD Branch. Various Mach numbers, from $M = 7.5$ to $M = 15$, were used to determine the flow field environment and temperature at the face of a roller for an orientation with the front of the roller facing directly into the direction of travel. Figure 4-10 shows the predicted heating rate and temperature distribution along the payload bay door roller at $M = 10.5$. The notations q_{cw} refers to “cold wall” and q_{hw} refers to “hot wall.” In this figure, the CFD solution assumes a steady-state solution, meaning that given enough time, the flow will develop into the calculated results. This is a reasonable assumption for high-speed entry because the flow field will form very quickly. The wall temperature is calculated by assuming radiation equilibrium. This means that the amount of heat that is being absorbed by convective heating is the same amount of heat that is being expelled through re-radiation. Also seen in the upper right of figure 4-10 are two photographs of payload bay door rollers. The photograph for OV-105 shows an intact roller, and the photograph for OV-102 (*Columbia*) clearly shows the erosion of the exposed titanium surface on the front face of the roller.

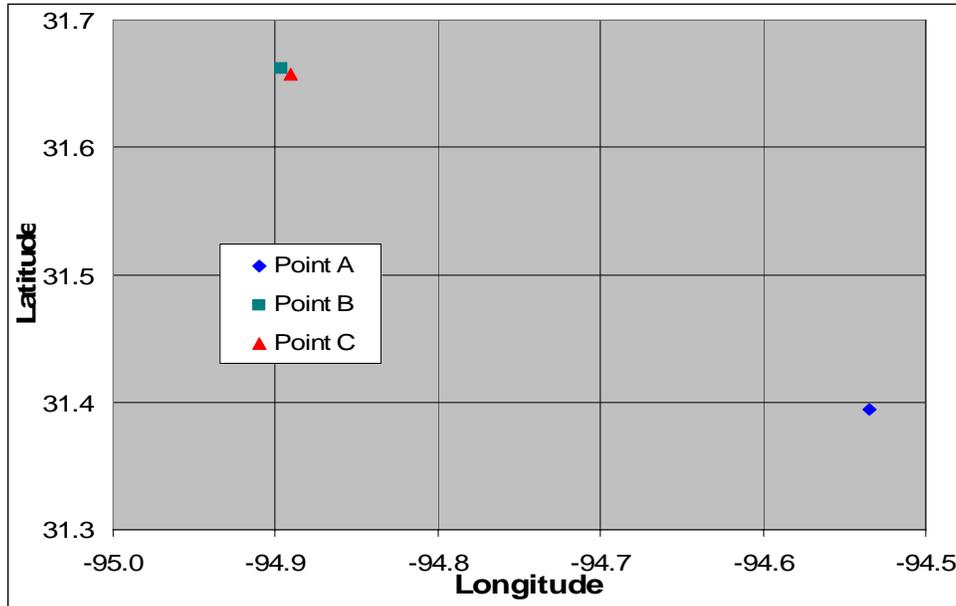
Figure 4-11. Plot for a pair of number strings that was interpreted for three different latitude/longitude formats.

Finding. The lack of a single, standard data format for latitude/longitude data and the potential ambiguity that is associated with the need to convert data of different formats resulted in possible data errors.

Figure 4-11 shows a plot for a pair of number strings (31 39439 and 94 53462) that is interpreted for three different latitude/longitude formats. Point A shows the numbers interpreted as the DD.ddddd format (31.39439° N, 94.53462° W). Point B shows the numbers as a DD MM SS.sss format (31° 39' 43.9" N, 94° 53' 46.2" W). Point C shows the numbers as a DD MM.mmm format (31° 39.439' N, 94° 53.462' W).

In this example, Point A is approximately 28 miles from Points B and C; while Points B and C are less than six-tenths of a mile apart. This example demonstrates the magnitude of error that can occur if the wrong data format is assumed and a necessary conversion does not occur (or an unnecessary conversion is performed).

Recommendation A10. Global Positioning System receivers used for recording the latitude/longitude of recovered debris must all be calibrated the same way (i.e., using the same reference system), and the latitude/longitude data should be recorded in a standardized format.¹⁷
